## Appendix 5

### Traffic and Parking Group Report 2020

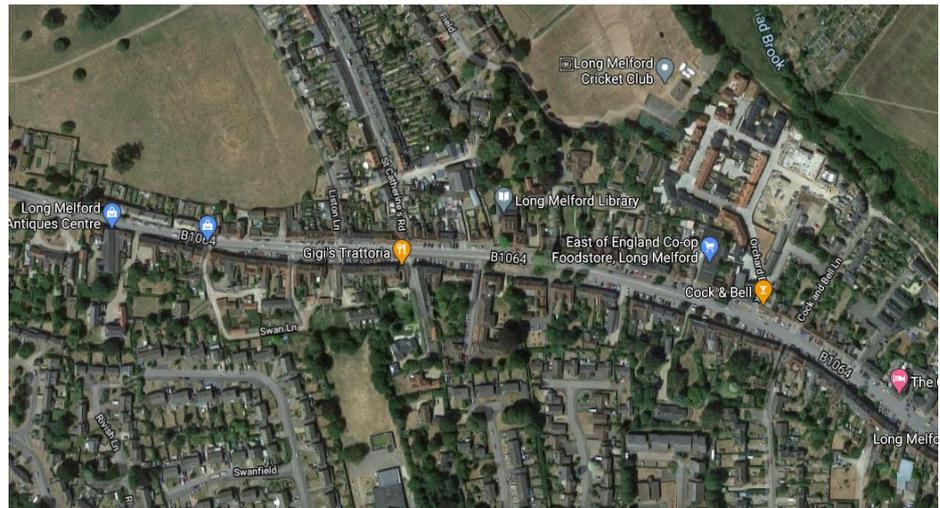
**5.17** Although there is extensive provision for parking along both sides of Little St Mary's and Hall Street, demand for spaces is high. Cars, vans and in some cases, lorries park on or across pavements, sometimes in a disorderly fashion,

forcing pedestrians, disability scooters and people with pushchairs and young children to pass in the road particularly at the southern end. Issues with traffic, parking and pedestrian safety<sup>10</sup> detract from the visitor experience in the village centre and are likely to have a negative impact on visitor numbers and the local economy.

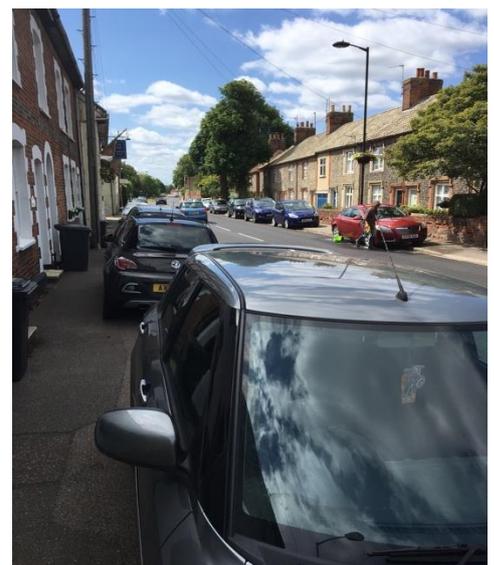
**5.18** Little St Mary's is a 2-way road bordered by a mix of small to mid-sized terraced cottages. Most are residential in use but there are several businesses including shops, a beauty salon, a funeral director, a veterinary surgery and two café/restaurants (both currently empty). Car parking is of concern, particularly in the narrow southernmost stretch, where most vehicles (on both sides) are habitually parked on the pavement to avoid damage from passing traffic. This in turn causes severe problems for pedestrians (particularly those on mobility vehicles or with pushchairs or wheeled shopping baskets) who cannot pass safely along the pavement and have to walk into the road on occasions.
